February 13, 2013

Re: Sage Mine and Exploration Update, San Juan County, Utah

Sage Exploration (UTU-74646 and E/037/0184), Sage Monitoring Wells (UTU-74647 and

E/037/0188) and Sage Mine (S/037/0058)

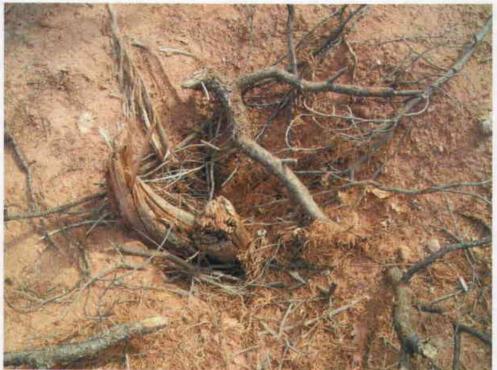
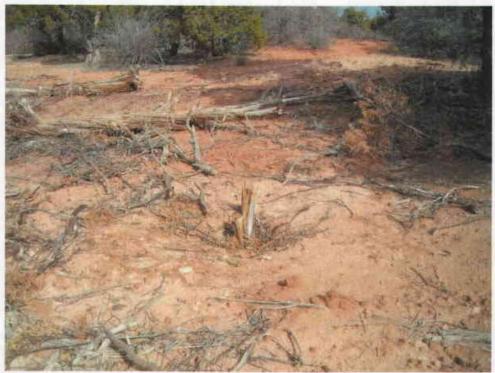
• Drill hole SP-11-006, which apparently had not been plugged during previous reclamation activities was attended to on November 12, 2012. The hole was backfilled with cuttings and an expanded foam plug was placed in the upper 2-7 feet below ground level. The top of the hole was then filled with soil and seeded.

Drill hole found with Branches placed in the hole

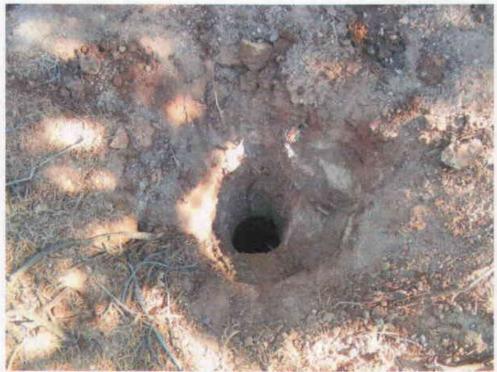
Drill hole with branches removed

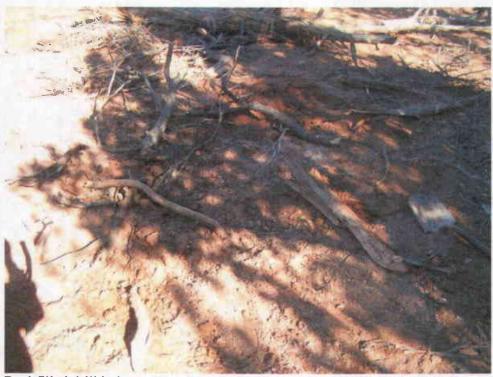
Backfilled drill hole

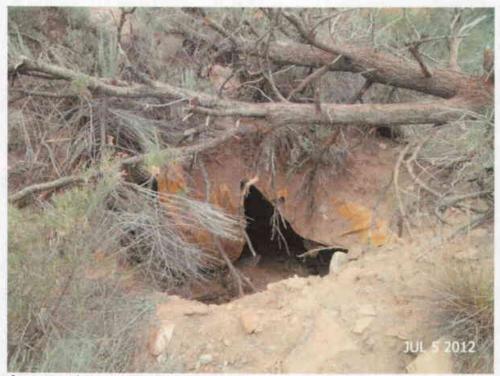
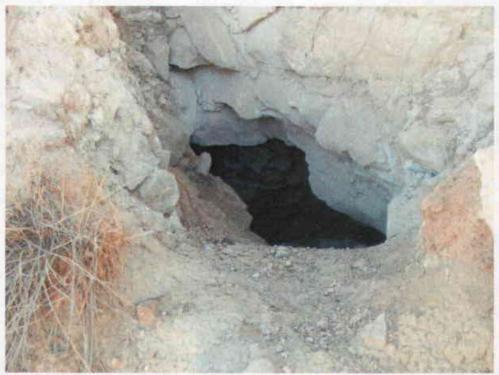
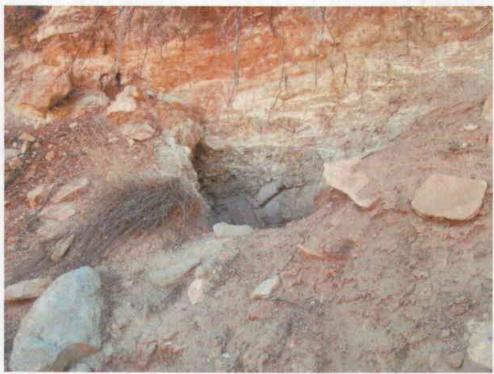
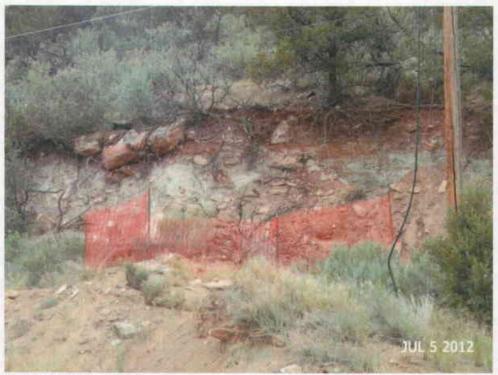
- The portal of the mine had been backfilled by a previous mine operator for safety reasons while the mine was on standby. When we acquired the property, we found that the timbers under the fill material had collapsed over time resulting in subsidence and the creation of openings to the surface at the portal and in a second area located a short distance into the decline. We backfilled both of these locations on November 26, 2012, effectively re-sealing them and preventing unauthorized access by the public.

Open portal caused by collapsed timber

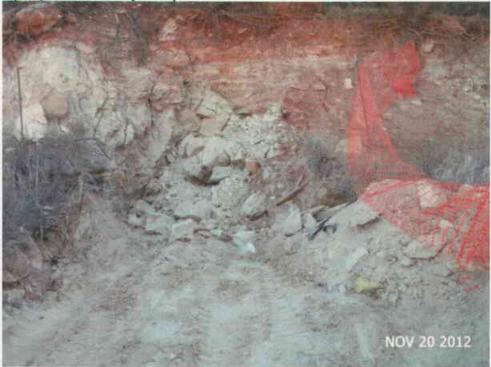
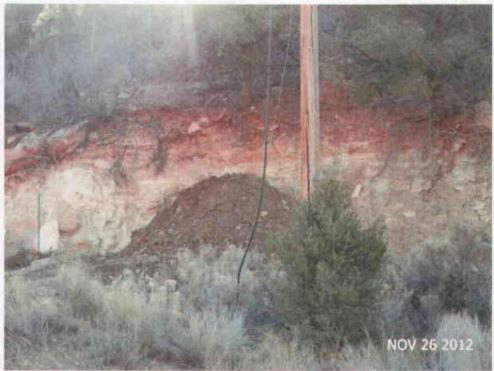
Backfilled portal

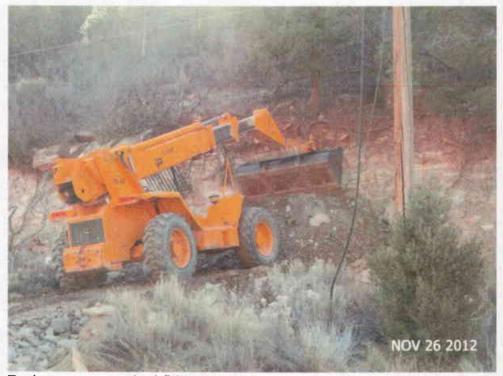
Equipment operator backfilling portal

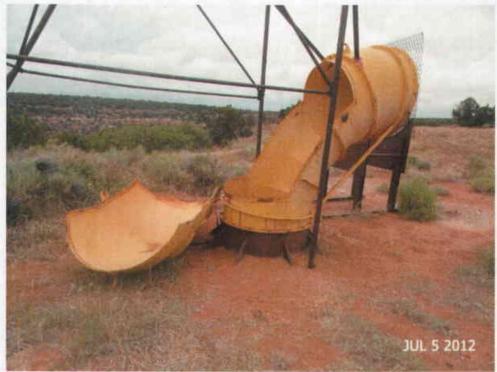
Open Vent Shaft

- The vent shaft shroud, which had been partially disassembled, has been reattached and welded shut preventing public access.
- Locks were placed on the two buildings to prevent public access.

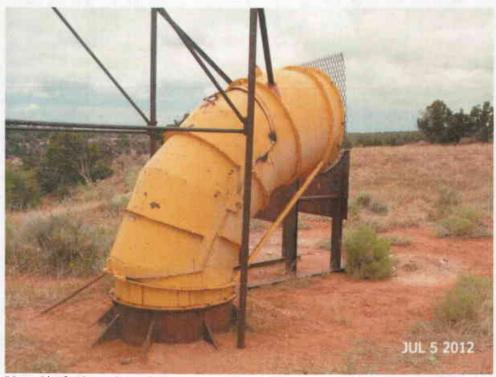
Vent Shaft Shroud welded on

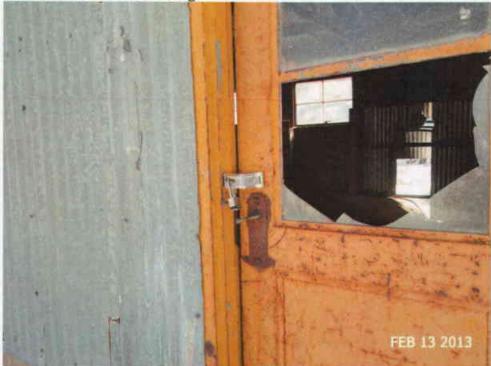
Lock installed on east building

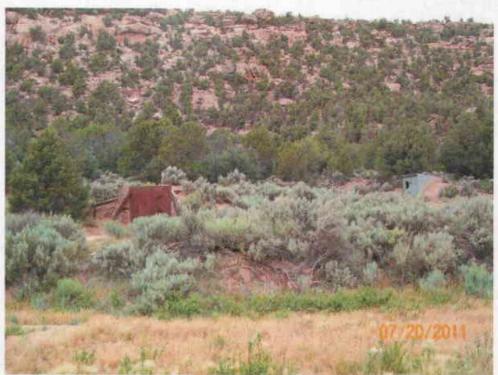
- General housekeeping, including removal of old hoses and debris, was completed in November.
- The powder magazine has been cleaned out but the door does not shut, as the floor has heaved. The primer magazine is empty and the door is partially silted in. we plan to repair and secure both doors in the spring.

Powder magazine (left) Primer Magazine (right)

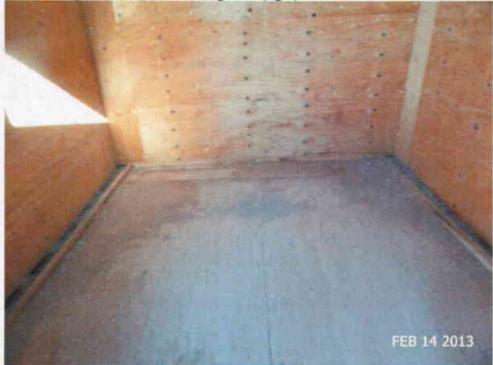
Cleaned out powder magazine

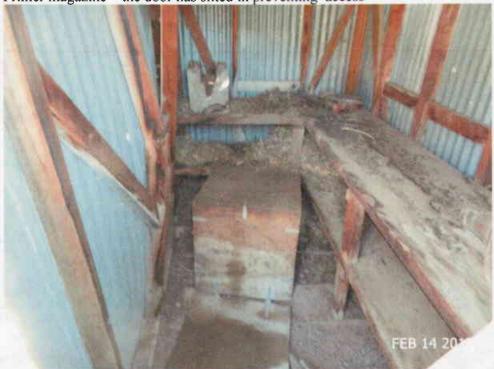
Primer magazine - needs cleaning out
